*Environmental engineering and ecological  
baseline investigations along the  
Yukon River-Prudhoe Bay Haul Road*

CRREL Report 80-19

Jerry Brown and Richard L. Berg, Editors

UNITED STATES ARMY  
CORPS OF ENGINEERS  
COLD REGIONS RESEARCH AND ENGINEERING LABORATORY  
HANOVER, NEW HAMPSHIRE, U.S.A.

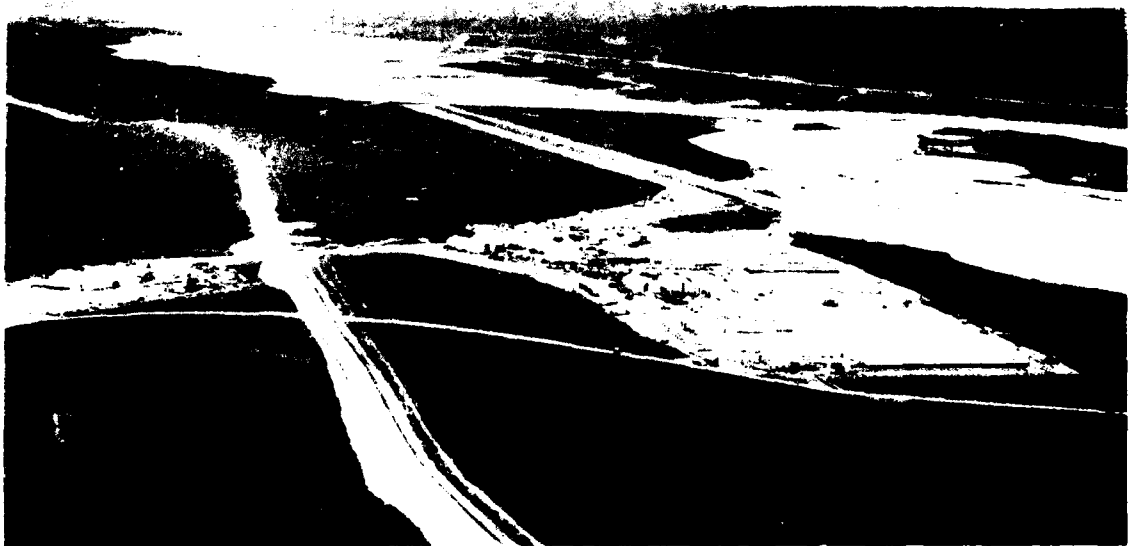
Figure 8. Road crossing foothills between Happy Valley Camps, 11 August 1976. Sagavanirktok River is to the east. The gravel-filled fuel gas line trench is seen adjacent to the road on the right side of this ice-rich permafrost setting. The oil pipeline is across the river.

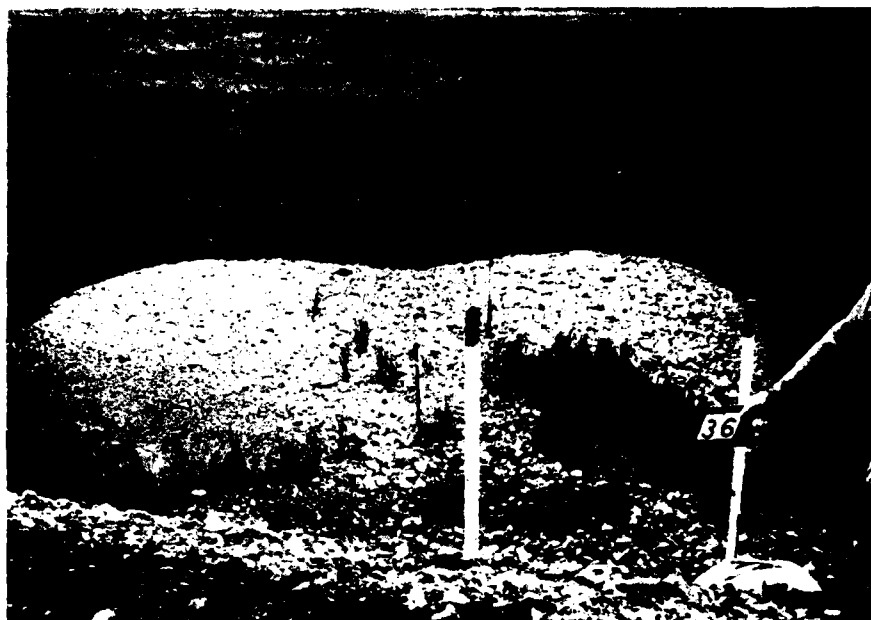
Figure 60. Debris deposit at outlet of culvert, site 132-C1, August 1977.
